Emergency Treatment with Bistite II DC Balancing the Art, Science, and Business of Dentistry

By Jeffrey C. Hoos, DMD, FAGD

As appeared in *J. Morita's News & Views*

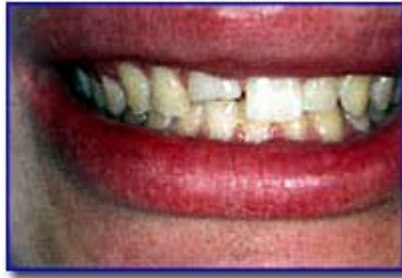
Figure 1

Many offices use an answering machine. I prefer using a very good answering service because the patient is reassured that the message is received. I received a phone call from the service at 3 pm on a Sunday. The patient was hit in the mouth during a fight and broke off his right upper central incisor (**Figure 1**). The patient was not experiencing any discomfort but was very concerned about the upcoming prom and how he would look. Fortunately the tooth piece was retrieved and kept in a plastic bag with water for hydration (**Figure 2**). If the tooth fragment had not been kept this way then the clinician would have to rehydrate the tooth.

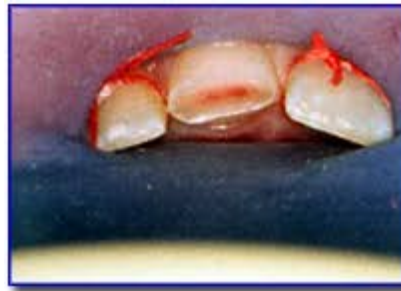
Figure 3

A rubber dam was placed around the tooth without a clamp so that no additional pressure was placed on the tooth. The pulp was exposed but there was no evidence of bleeding and the patient did not complain of any discomfort (**Figure 3**).

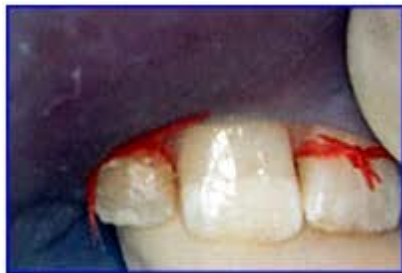
Figure 4

The piece was tested in place to assess the fit of the broken piece; the fit of the fragment was "perfect" (**Figure 4**). An articulating paper forcep was used to hold the piece of tooth because of the ease-of- use, no pressure is required to keep the piece of tooth in place (**Figure 5**).

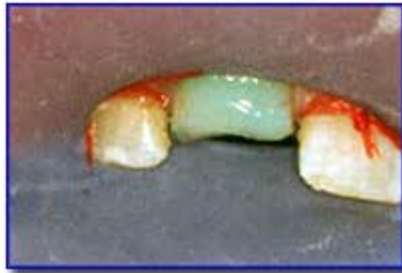
Figure 6

Acid etch was placed on the enamel surface of the tooth but none on the dentin or exposed pulp (**Figure 6**). Bistite DC is a self-etching cement but the acid was required for only on surfaces of teeth that have not been touched by a bur. The fragment was micro-etched with air abrasion and two small quarter-round bur holes were placed for additional retention (**Figure 7**). The fragment and the tooth were treated with the Bistite II DC primers for conditioning the tooth to receive the cement (**Figure 8**).

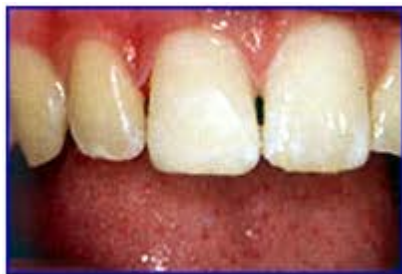
Figure 9

The fragment was moved into place with the Bistite II DC Clear cement and light cured for initial stabilization (**Figure 9**). The tooth fragment was restored in proper position with a wonderful cosmetic result (**Figure 10**). Note the lack of a cement line. The fragment has been in place for 4 years and the tooth shows no x-ray pathology or symptoms.
